Thermal Runaway Testing of 18650 Lithium Ion Cells

Chad Lobato
Kyle Adams, Blake Cardwell,
Jacob Dembeck, and Joshua Fedders

EnerSys Advanced Systems / ABSL
Longmont, Colorado

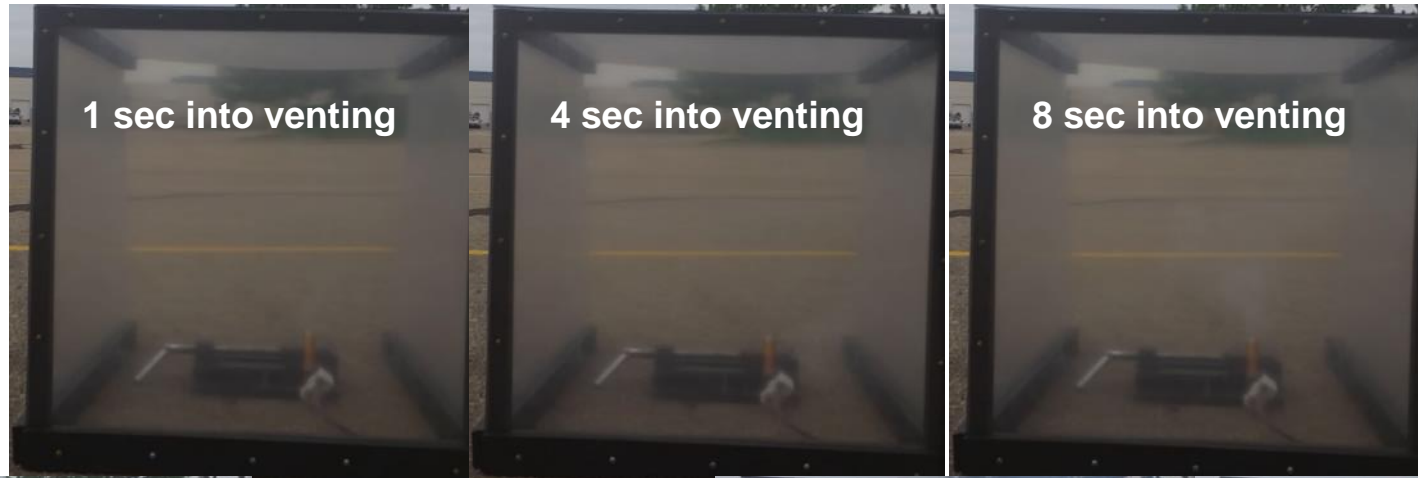
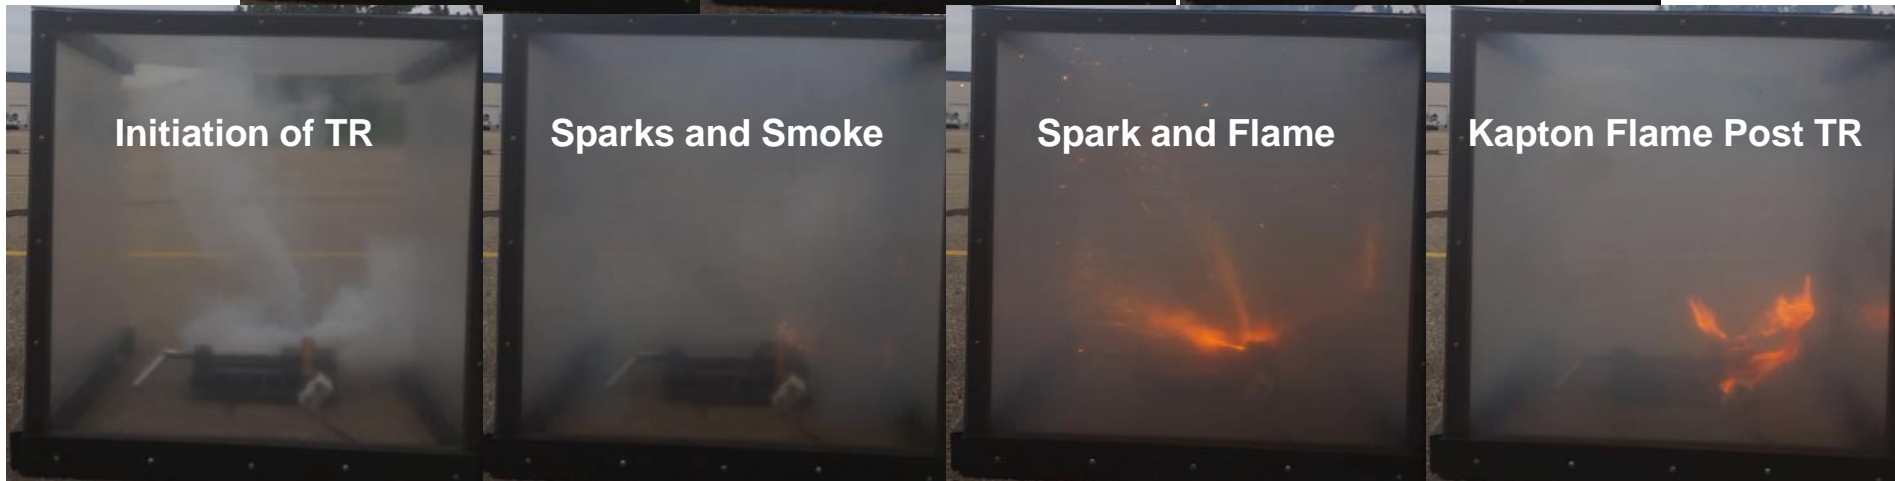
HCM Single Cell TR Test

- **Testing was first performed on Sony 18650HCM cells**
- **The HCM is a 1.5 Ah cell**
- **As the HCM approaches thermal runaway, it begins to vent a small amount of smoke**
 - The cells would typically vent smoke for 10-15 seconds prior to going into full thermal runaway
- **At the time of thermal runaway, a jet of flame, sparks, and smoke are emitted through the center of the cathode assembly**
 - During thermal runaway, the jet would typically last 2-3 seconds
- **Cell can temperature was hot enough to ignite the kapton tape wrap and cause additional fire around the anode, or can, of the cell**

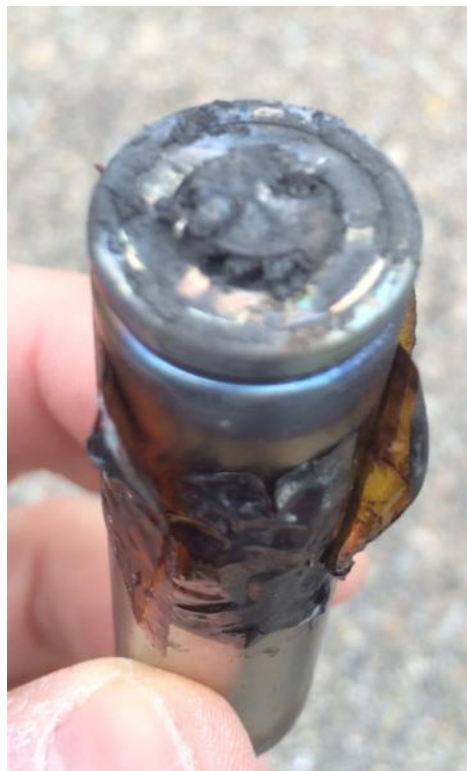
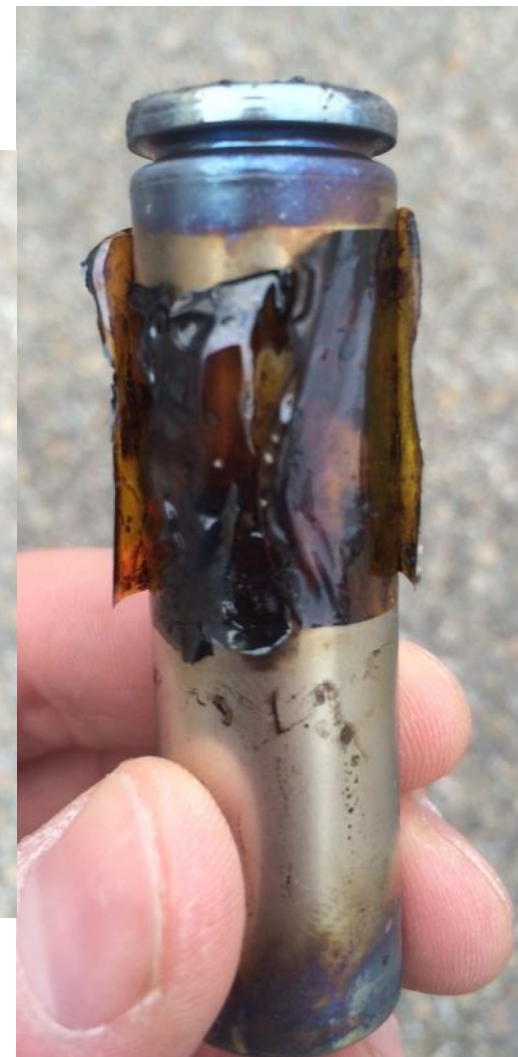
HCM Single Cell TR Test

- The cells were visually inspected following TR
- Cathode assembly remained intact
 - The TR jet pierced through the burst disk and cathode top cap
- No signs of side wall rupture in the anode
- Heat discoloration of the cell can

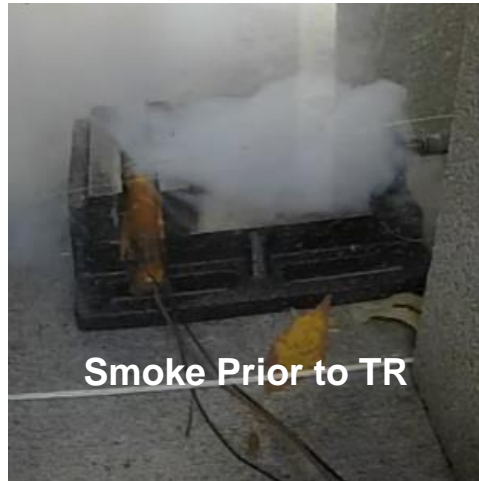
Smoke Prior to TR

- Testing was then performed on the Molicel IHR-18650C (Moli C) cells
- The Moli C is a 2.2 Ah cell
- **As the Moli C approaches thermal runaway, it is much less consistent than the HCM cell**
 - Some cells would vent a significant amount of smoke, others would vent no smoke
- **At the time of thermal runaway, the crimp holding the cathode assembly would fail**
 - The cathode assembly was blown out of the cell
 - The internal jelly was blown out of the cell can
 - Thermal runaway is much more energetic than the HCM
- **Thermal runaway of the Moli C is much shorter duration than HCM**
- **During cell level testing, flames were not observed coming out of cell**
- **Cell can temperature was hot enough to ignite the kapton tape wrap and cause additional fire around the anode, or can, of the cell**

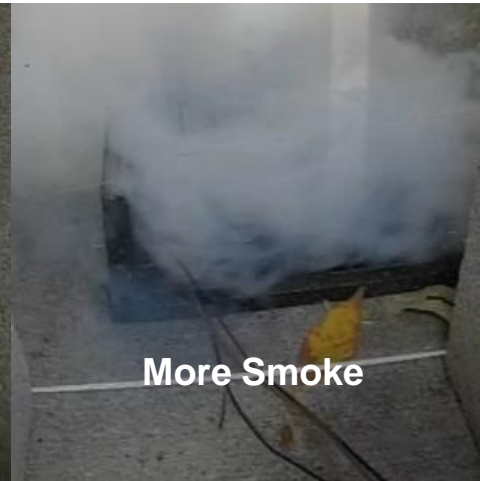
More Smoke

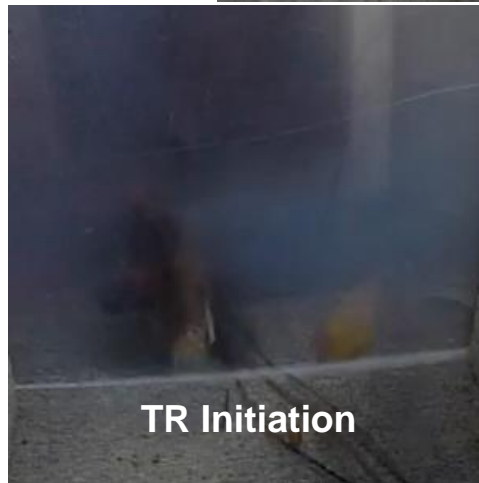
TR Initiation

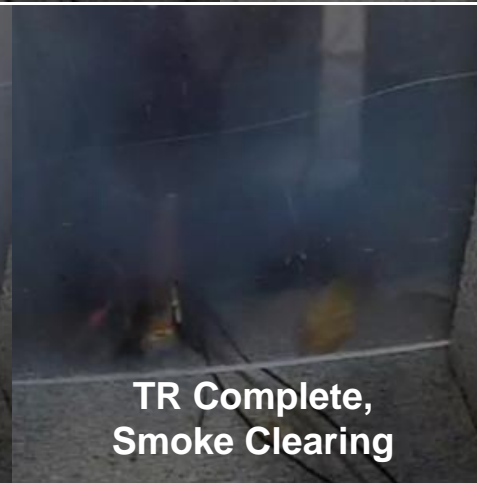
TR Complete,
Smoke Clearing

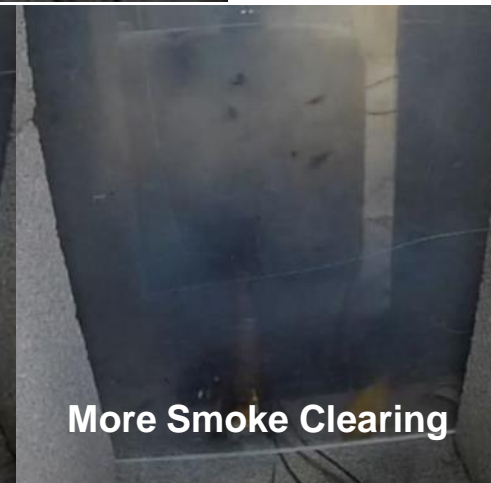
More Smoke Clearing

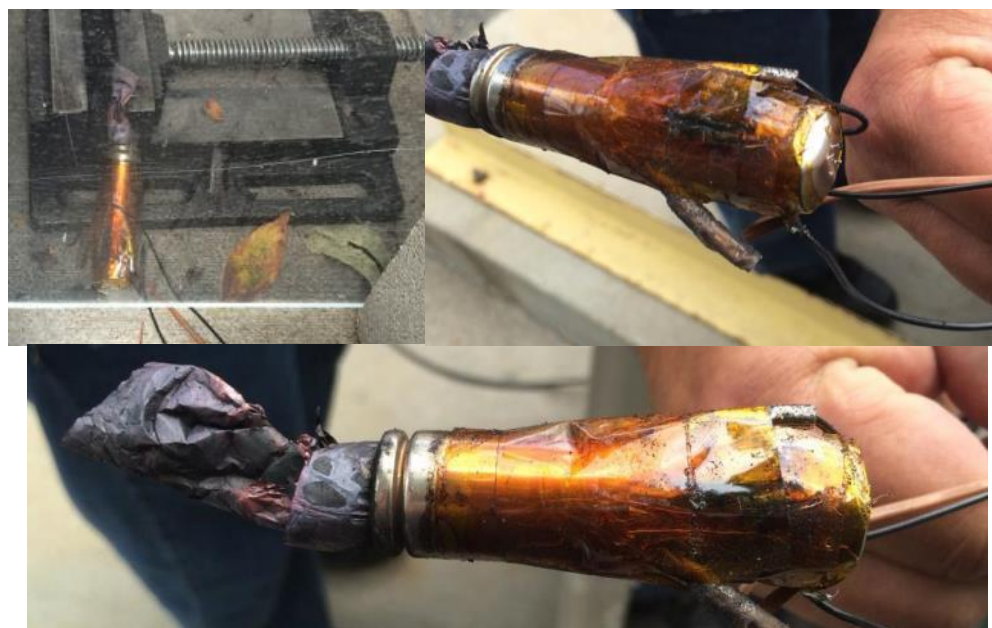
Moli C Single Cell TR Test

- The cells were visually inspected following TR
- Cathode assembly ejected from the cell
- The jelly roll was ejected from the cell
- No signs of side wall rupture in the anode, but the can show significant bulging from the internal pressure
- Heat discoloration of the cell can

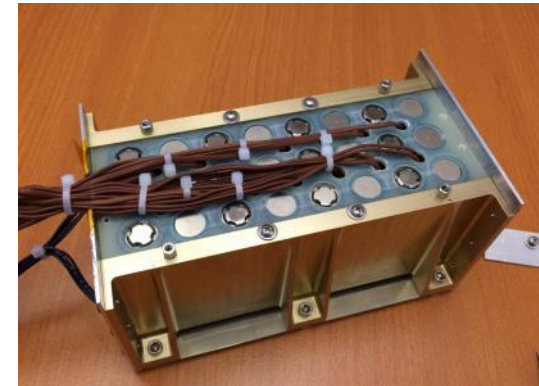
Moli C Battery Level TR Test 1

- **24 cells built into the same cell block configuration as the HCM battery**
 - The cells were not connected electrically
- **Battery had 20 thermocouples attached to the cells to measure cell can temperatures**
- **5 heaters were placed on the cells as shown**
 - Tests were run using heater #1, #3, and #4 (showing results for heater #1)

Thermocouples attached to sidewall of cells → Qty 20

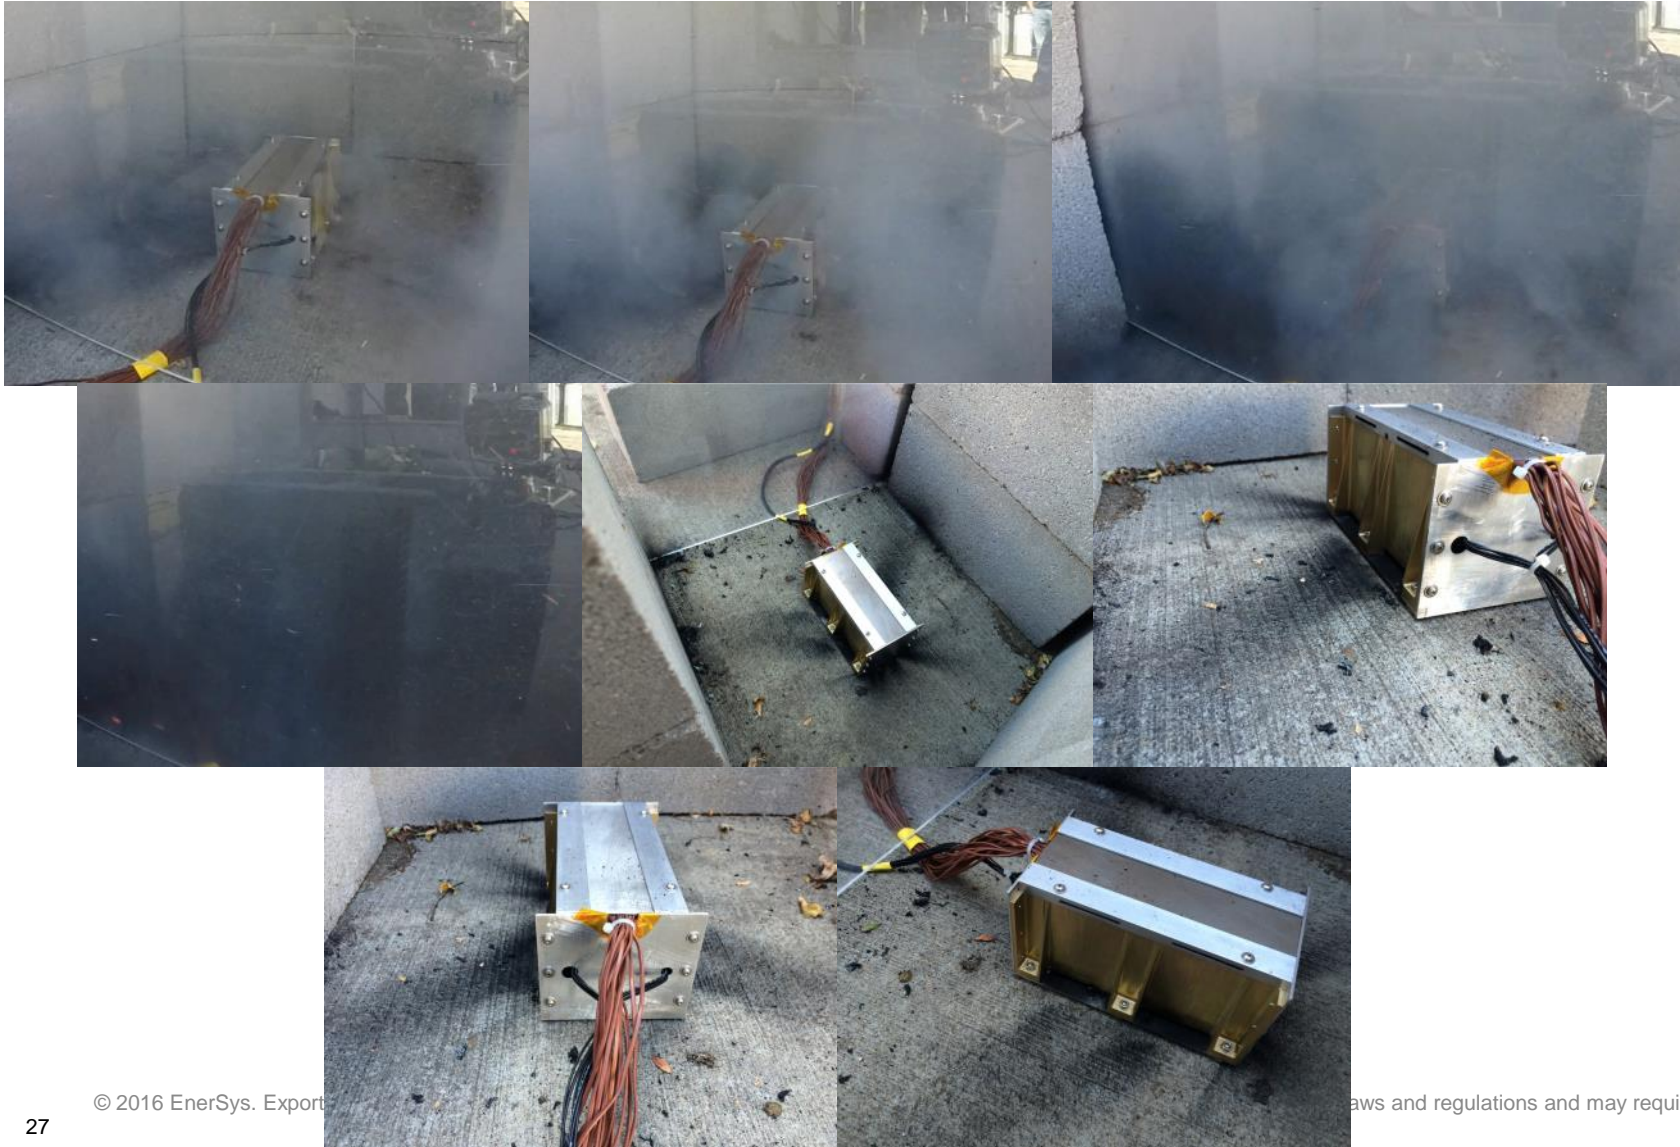
Moli C Battery Level TR Test 1

- **The trigger cell went into TR as expected**
- **No propagation of TR occurred**
- **Battery maintained structural integrity**
- **No flames were visible during the TR**
- **Cathode was blown off the cell during**
- **Fragments of the jelly roll were ejected**
- **Jelly roll material was deposited on neighboring cells resulting in one cell shorting (C1S2)**
- **The anode showed severe swelling due to the TR**

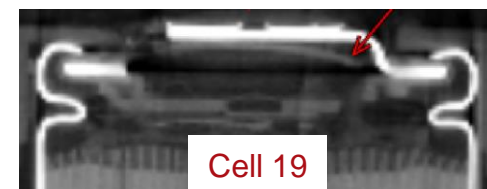
Moli C Battery CT Scan – Results

Neighbor cells normal safety device activation

- Three cells show CID activation (cell 7, 15, and 21)
 - Pressure disk separated from support disk, but not ruptured
 - Two cells show inconclusive results, CID may have activated but CT scan image not as clear as others (cell 2 and 14)
- Four cells show vent activation (cell 1, 8, 19, and 20)
 - Press disk ruptured at vent groove
- One cell appear undisturbed (cell 9)

Vent Activation

CID Activation
